TECHNICAL SERVICE BULLETIN

7.3L - Illuminated MIL With Misfire Or Lack Of Power And DTCs P0300, P0316, And/Or P0301-P0304 - Built On Or Before 28-Sep-2020

20-2370
09 November
2020

Ford 2020 F-53 Motorhome Chassis	Engine: 7.3L
--	--------------

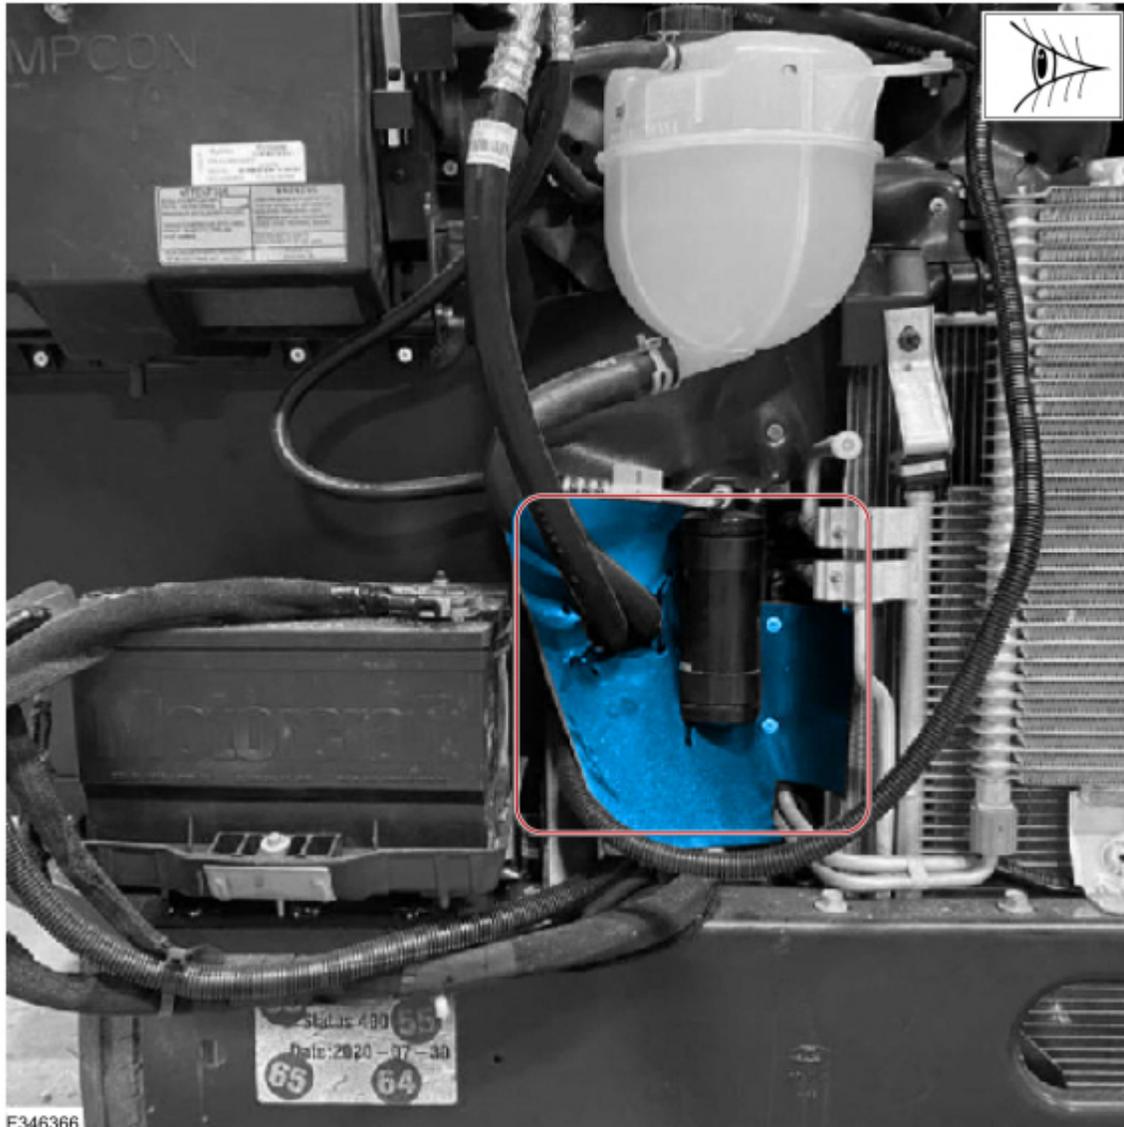
Figure 1

1. Locate the passenger side engine compartment baffle. Does the baffle completely cover the area between the radiator assembly and the battery tray as shown in Figure 1?

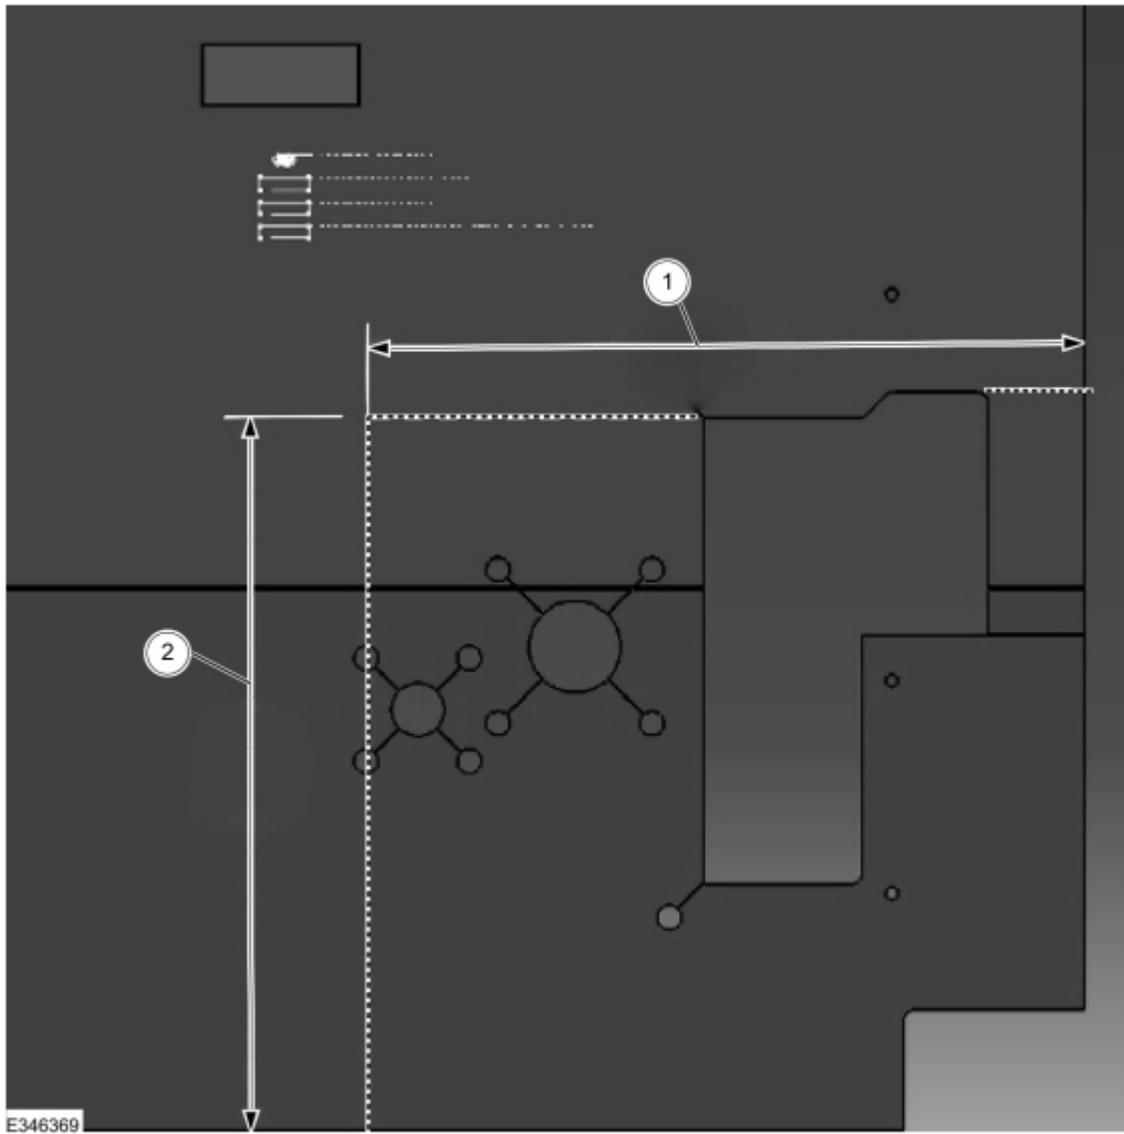
Figure 2

Item	Description
1	297 mm
2	295 mm

2. Trim the engine cooling baffle on the passenger side using a suitable cutting tool. (Figures 2-4)
